**Archaeological Evaluation at**  
**St James's Church**  
**Weddington, Warwickshire**

January 2000

## Summary

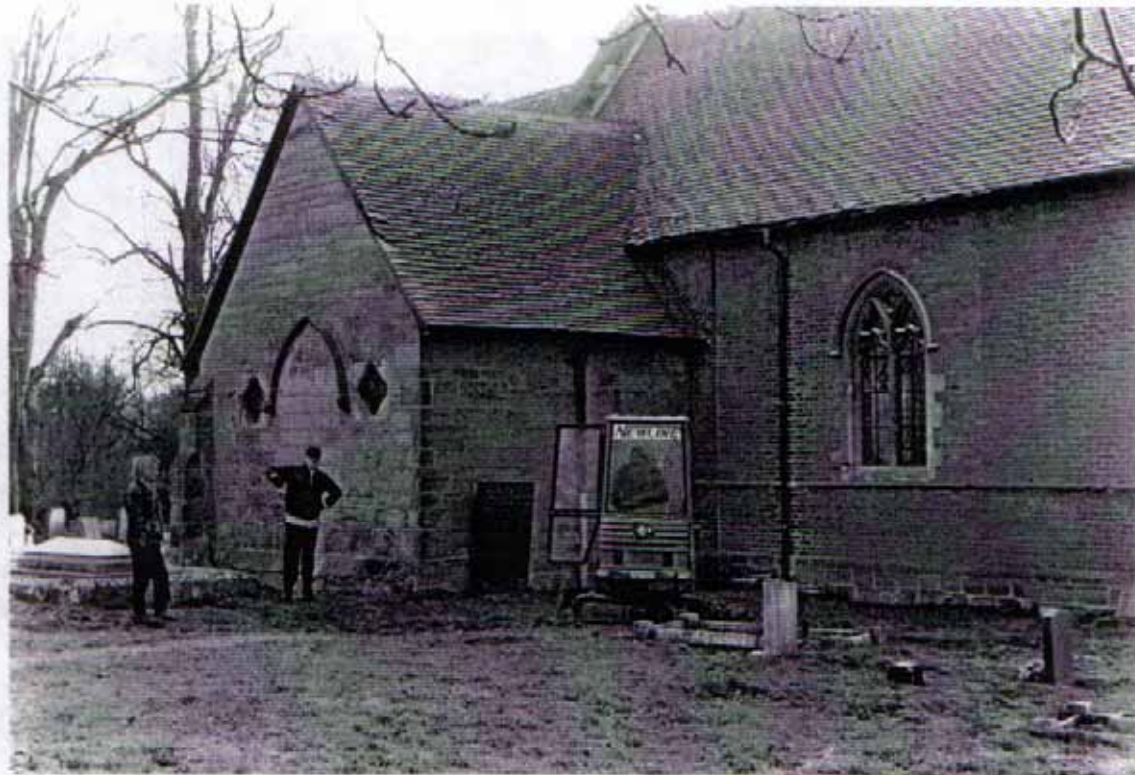
Fig. 5: Evaluation Area before Excavation

5.1 Two trenches were dug in an L-shape running from the north-west corner of the north transept to the west corner of the tower. Two graves, dating to the 1950s, lay within the original proposed line of the northern trench (Figs. 5 and 6). As it had already been stipulated by the Reverend Adams that these graves were to remain undisturbed it was agreed with the Planning Archaeologist, before excavation commenced, that the northern trench would veer around the graves to cause the minimum of disturbance in this area.

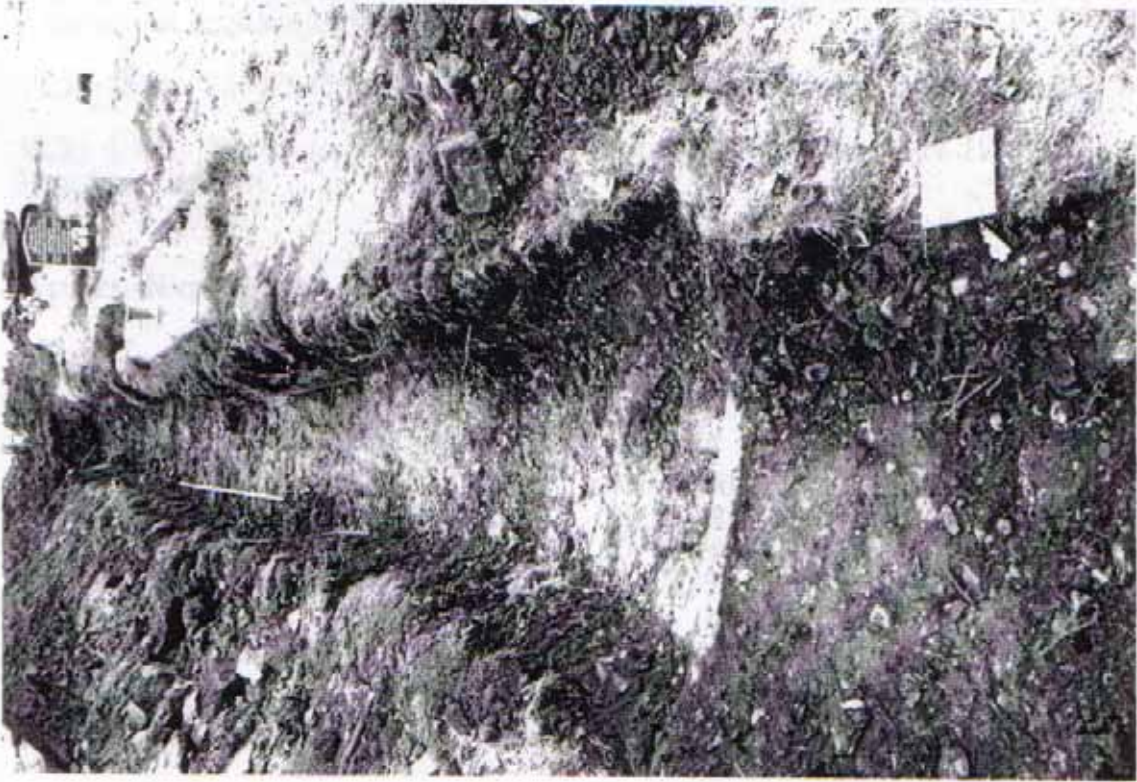
Fig. 6: Northern Trench

5.2 The northern trench measured 12.60m long by 1.10m wide and was aligned WSW-ENE (Fig. 6). The geological natural red clay, sand and gravel (9), lay at a depth of between 0.47m and 0.83m below the modern ground surface (at a maximum level of 80.16m aod).

5.3 At the eastern end of the trench, overlying the geological natural, was a spread of sandstone rubble (10) which was up to 0.38m deep and was cut (2) by the trench for a modern plastic drainpipe (3). In the remainder of the trench the geological natural was sealed by a layer of strong brown sandy loam subsoil (4), lying at the same level as the rubble. The rubble, subsoil and drainpipe were sealed by modern topsoil (1)

6.2 The area evaluated contained modern services and a spread of rubble. It is possible that the latter is a remnant of building demolition rubble from the earlier

church; the Rev. Tony Adams reported that such areas of rubble are located all over the graveyard.
